# Applying infrared thermography to a latest residential building in France: case study, verifying dwellings national thermal regulations RT 2012 mainly thermal bridges assessment

Harry Ramenah\*

University of Lorraine, Metz, France

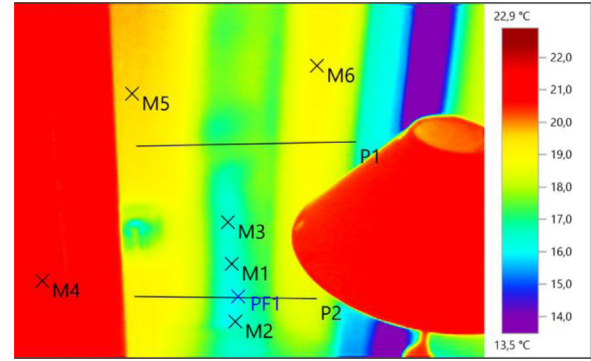
Fig. 1. Example of a thermal image.

All objects above the absolute temperature (T) emit IR radiation and the quantity of that radiation emitted by the object generally varies with its surface temperature that is proportional to  $T^4$ . The amount of IR radiation emitted is also affected by the efficiency of the surface radiating IR also known as emissivity ( $\epsilon$ ) [49–51]. The correlation between IR intensity and temperature is converted to a map of apparent temperature that is based on some assumptions such as variations in emissivity and this is considered in another section below. The thermal images from the thermal camera is known as thermograms and calibrated temperature thermal images is denoted as thermography. An example of a thermogram is indicated in Figure 1.

The scale and numerical values beside the image shows the relative temperatures due to different colors in the image.

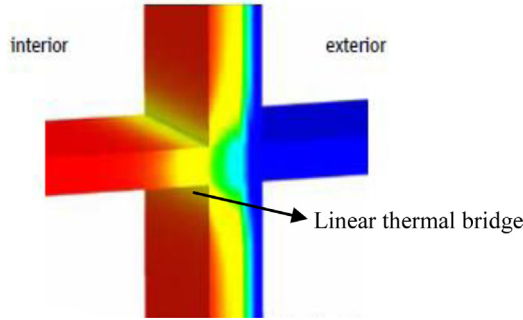
**Fig. 2.** Heat flow through balcony slab.

The thermal bridge effect at a vertical wall and balcony which is an extension of the concrete ceiling without thermal break is modelled [58,59] in Figure 2. In that figure, the red surface is the inner warm surface while the blue surface is the outer one; the color gradient from yellow to clear blue is showing heat flow to the outside through the balcony slab and the linear thermal bridge is the one that is measured by thermal camera. The temperature model distribution with thermal break is illustrated in Figure 3. In that figure, thermal break is providing a continuous insulating layer and has significantly reduced heat loss.

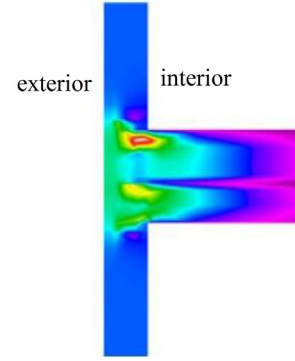
**Fig. 4.** Embedded beam in a wall.

They also neglected the thermal bridge effect at a concrete beam embedded in an external wall as represented in Figure 4. In this study case, the considered building has cantilevered balconies which is the most critical thermal bridges in a building envelope and more when cantilevers are non-insulated. Figure 5, illustrates a real image of the regarding building for this study case with cantilevered balcony. The concerning apartment is the upper ground floor indicated by the blue frame in Figure 5.

This thermal bridge was caused by the beam itself and the heat flow is imaged in [Figure 4](#) of [Section 3](#). The reference temperature is determined by the dark object on a branch of the tree in the real image. The maximum temperature difference is nearly 5 °C. The joints in walls play a major role of heat loss and gain between indoor and outdoor environments, which is the major cause of the “ghosting” phenomenon that is appearance of dark or discoloured patterns.

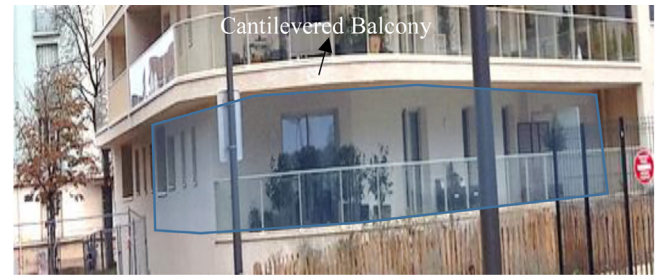
**Fig. 5.** Real image of the concerning building at upper ground.

The considered building for this study case is illustrated in Figure 5 and is supposed to be an example of a latest high performance building in France as it was finished in year 2021. The building is in the north-east of France which has a semi-continental climate characterized by cold and grey winters, accompanied by frequent snowfalls. The average temperature of the coldest months is nearly 1 °C. There can be cold spells, in which temperatures can drop as low as −10 °C or even below. Experimental conditions for the IR measurements are indicated in Section 2.3. The architectural design of the concerning apartment is illustrated in Figure 6 with internal insulation and the total surface area is 110 m<sup>2</sup>. The colored lines should indicate IR thermal measurements zones and orientations at each step of this study.

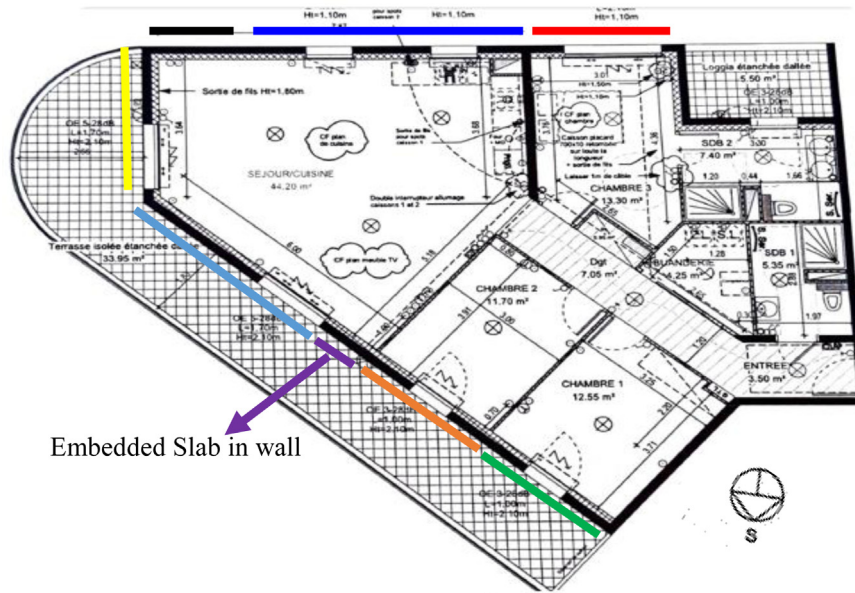
Fig. 6. Architectural plan of the apartment in the case study building.

The wall to wall thermal bridge is the master bedroom, having a north orientation, and indicated by the red line in Figure 6. The thermogram is showed in Figure 7a and the corresponding real image is illustrated on the right side to the thermal image.

The next wall to wall thermal bridge is in another bedroom, the green line in Figure 6. The thermal bridge again is at the junction of the internal bearing wall and an insulated wall facing the outside but in a south orientation. The thermograms and corresponding real image are displayed in Figure 11. Table 3, is indicating temperatures at variant locations in the thermal image. The temperature difference is nearly 5°C between the lowest temperature in the thermal bridge and the room temperature.

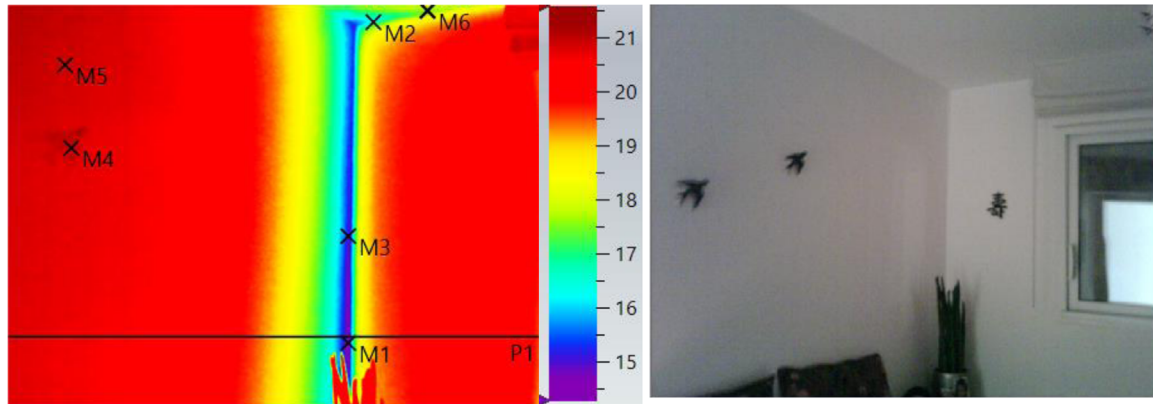
**Fig. 7.** Left is the thermogram of a wall to wall thermal bridge and real image on the right.

The wall containing the window in the real image is an insulated wall facing the outside and is at a junction with an internal load-bearing wall.

The blue color in the IR image indicates the wall to wall thermal bridge. This is identified in the thermogram by areas with lower surface temperature (blue color) in relation to intact areas (red colors).

The black bird which is a dark object is considered as the reference (reflection) temperature at 20.9°C and the measured room temperature is 21°C indicating that measurements are done in an optimal condition. M1 to M5 in the thermogram, are measured temperatures by IR camera as indicated in Table 1. The reference temperature is M4 (black object) as indicated by the observation column in Table 1 and M1 is the lowest temperature at 14.6°C. M5 is a random point showing that the red color is at the reference temperature.

It is also interesting to point out that temperatures M2 & M6 are part of the balcony thermal bridge.

The line P1 in the thermal image is the temperature profile and plotted in Figure 8, showing a substantial temperature drop at the wall junction. Therefore, this zone is very sensitive to moisture and uncomfortable spaces due to high difference in surfaces temperatures. The insulation layers for this kind of junction that was supposed to reduce heat losses, had increased the thermal bridging impact. If insulation layers were extended to the internal wall, then this thermal bridge would have been avoided beside the augmentation in cost of construction.

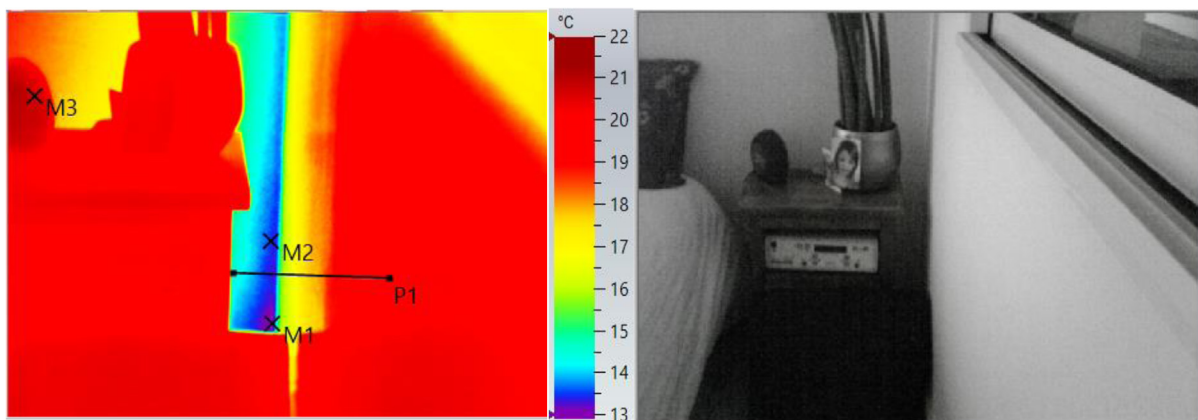
**Fig. 9.** Lower part of the wall to wall thermal bridge.

The lower part of this wall to wall thermal bridge is showed in Figure 9 with the corresponding real image. In Table 2, the lowest measured temperature is close to 13°C indicated by M1, for a reference temperature 20.8°C indicated by M3, which is a dark alarm clock in the real image. Line P1 in the thermal image is the profile temperature that is plotted in Figure 10. The difference between the reference temperature and lowest temperature in the thermal bridge is 7.9°C.

This thermal bridge is again caused by a lack of extension of the insulation on the uninsulated wall or a missing of thermal break at the walls junction during construction. The colors in the thermal image have been standardized in the Testo software for a better overview of temperature variation.

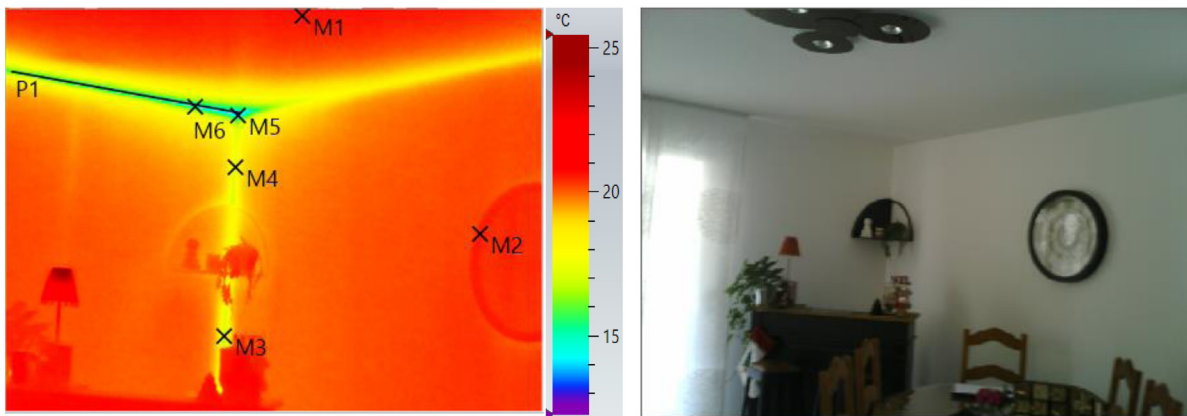
**Fig. 12.** Balcony wall thermal bridge on the left and real image on the right.

This first type of thermal bridge is along the dark and yellow lines as indicated in [Figure 5](#) including the junction between the two walls. The thermogram and its corresponding real image are displayed in [Figure 12](#).

The wall containing the clock in the real image has a north orientation and the perpendicular wall has a north west orientation. The reference temperature is taken as M2 due to the thick dark frame of the clock. It can be concluded that an equilibrium condition is reached as the ceiling temperature M1 is the same as M2. [Table 4](#), gives temperatures at different locations. The least temperature is given at M5 position whereas M3 & M4 are temperatures at the wall to wall junction. Line P1 is temperature profile in the balcony wall thermal bridge and is represented in [Figure 13](#). The ultimate temperature difference is 7.2 °C. It is clear, that this balcony thermal bridge should cause the highest percentage of energy loss. The balcony slab board that is working as heat transfer fins has caused a direct heat flow path between spaces with different thermal conditions.

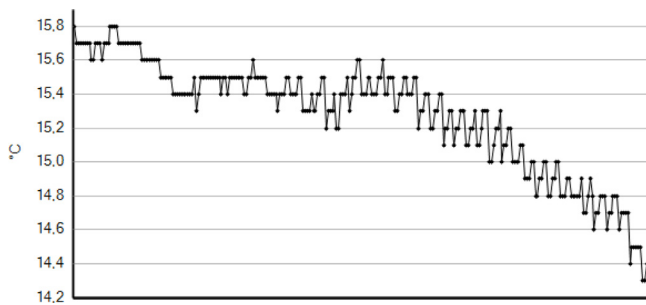
**Fig. 13.** Temperature profile in the thermal bridge in the IR image.

explained in Section 2.5. Internal temperatures at different locations of that zone were also measured by a contact temperature sensor PT 100 and are similar to those of the thermal camera. During this survey, the internal ambient temperature,  $T_i$ , was 21 °C and the external ambient temperature  $T_0$  was 5 °C. Various parts of missing thermal insulator are visible on the thermogram of Figure 21 and the corresponding real image on the right of the thermal image. The measured internal surface temperatures are given in Table 9.

For dwellings the value of TI should not be less than 0.75 as this value matches an internal surface temperature of 13.8 °C when the usual inside temperature is 20 °C and outside temperature is −5 °C. As consequence, missing insulation should bring condensation that would arise if the outside temperature was below −5 °C or the inside air was more saturated with water vapor.

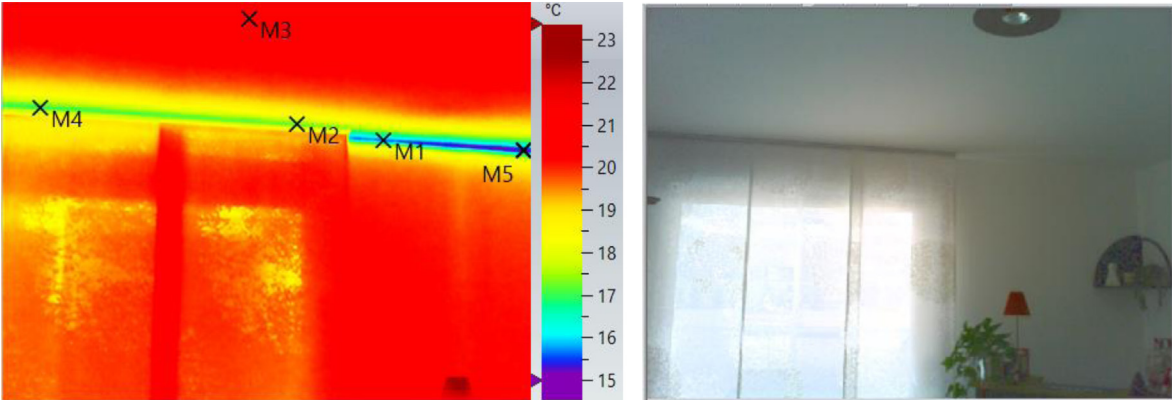
Fig. 14. Left: Balcony thermal bridge along the yellow line. The real image on the right.

The yellow line in [Figure 6](#) is the bridge in the north west orientation and above the window door. The concerning balcony and window door are also visible in [Figure 5](#). The results are presented in [Figure 14](#) and [Table 5](#). This thermal bridge is substantial as it still appears even behind the curtain rail in a clear blue color. The greatest temperature difference is 5.7 °C.

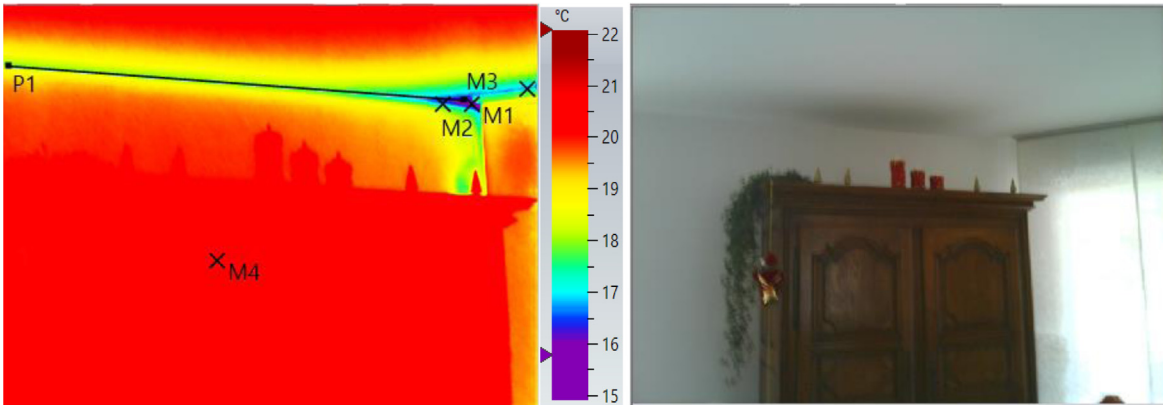
Fig. 15. Left: Thermograms between yellow and clear blue lines. Real image on the right.

The following results are at the angle between the yellow and clear blue lines, that is between the south and south west orientation. In this case, the line P1 is not very significant as the IR camera in [Figure 15](#) was facing the angular zone. The plot is simply indicating the temperature drop at the corner. [Table 6](#) is the corresponding temperatures at several locations in the IR image.

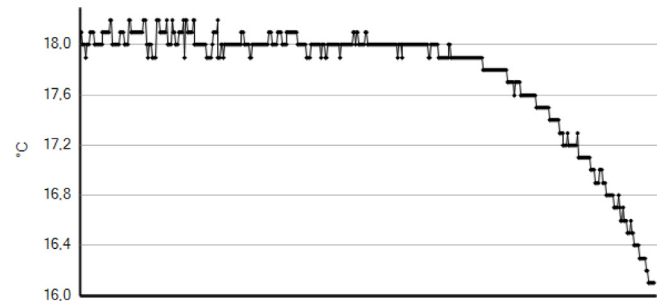
Fig. 16. Temperature profile of P1 in the IR image.

The profile temperature along the balcony thermal bridge facing the south orientation is indicated in [Figure 16](#). The linear part of the graph is not significant due the IR camera position as explained in [Section 2.3](#).

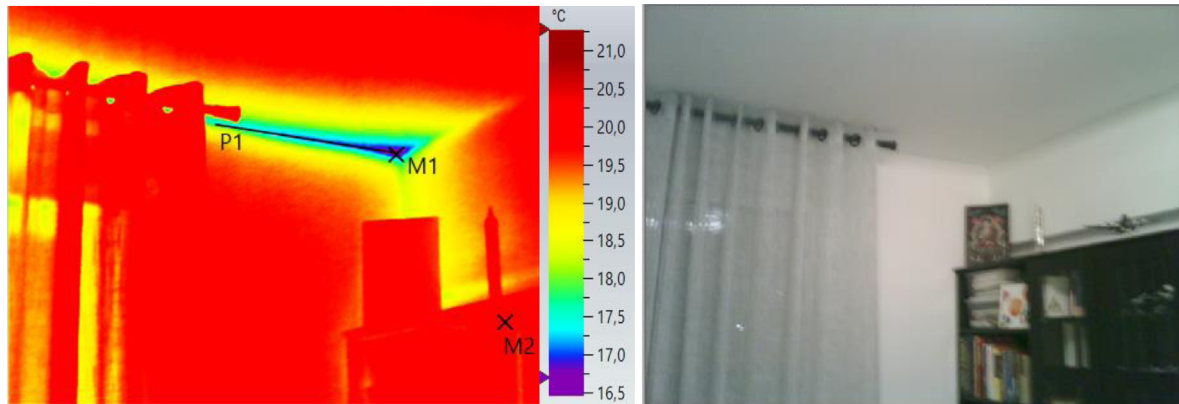
**Fig. 17.** Left: Thermogram of the room at orange line and the corresponding real image on the right.

The balcony thermal bridge is all around the building structure and we have chosen to give results for this last junction at the orange line in [Figure 6](#). This zone has a south orientation. The least measured temperature at M1 position in the thermogram of [Figure 17](#) is 16.6 °C as indicated in [Table 7](#). The line P1 is the temperature profile along the balcony wall thermal bridge and represented in [Figure 18](#). We retain a temperature difference of 4.4 °C for this thermal bridge.

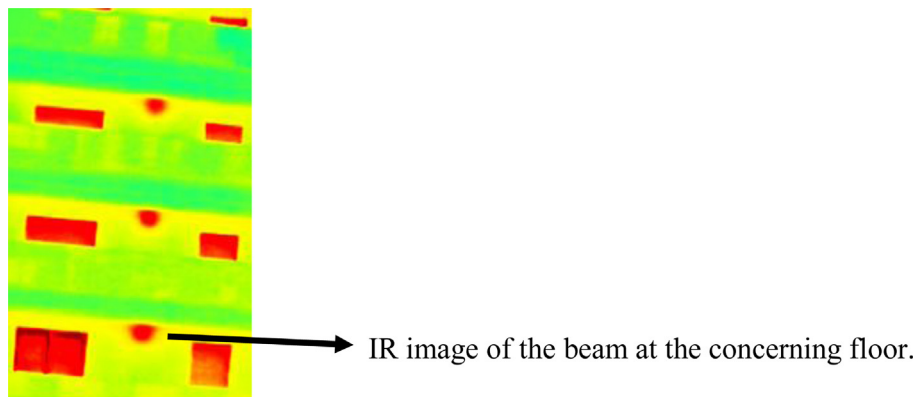
**Fig. 19.** Beam wall thermogram from outside.

The beam is clearly visible on the outside thermogram at various floor of the building as illustrated in Figure 19. The thermogram of this thermal bridge and the real image are illustrated in Figure 20.

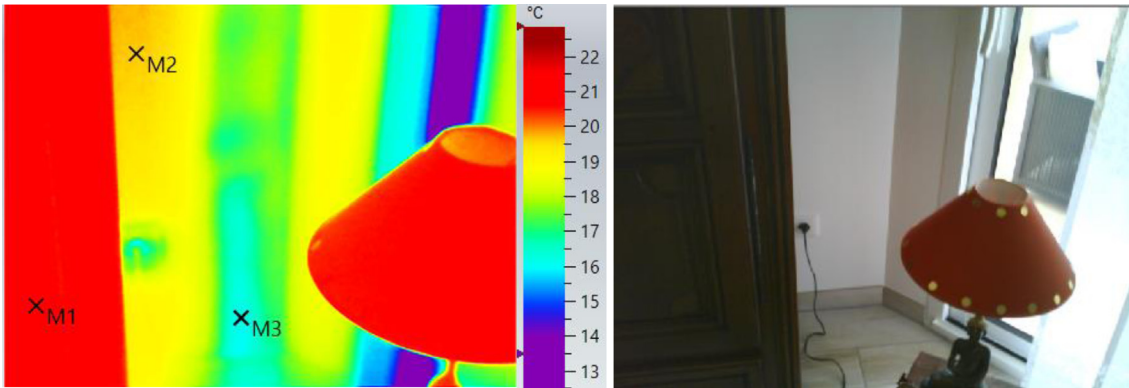
Fig. 21. Thermogram of the zone of missing insulator and the real image on the right.

Missing thermal insulator have been listed at few zones of the apartment during the thermal survey. One of the zone is between the yellow and clear blue lines in [Figure 6](#). It seems that there are missing thermal insulator at various area of the wall and only results regarding the lower part of the wall are considered. We should also consider the temperature index for an area on the thermal image as

M3 is considered as the internal surface temperature  $T_{si}$  at 16.1 °C for the temperature index determination given by equation 1 in Section 2.5 and the other temperatures in this equation are indicated above. The determined TI value is 0.694.

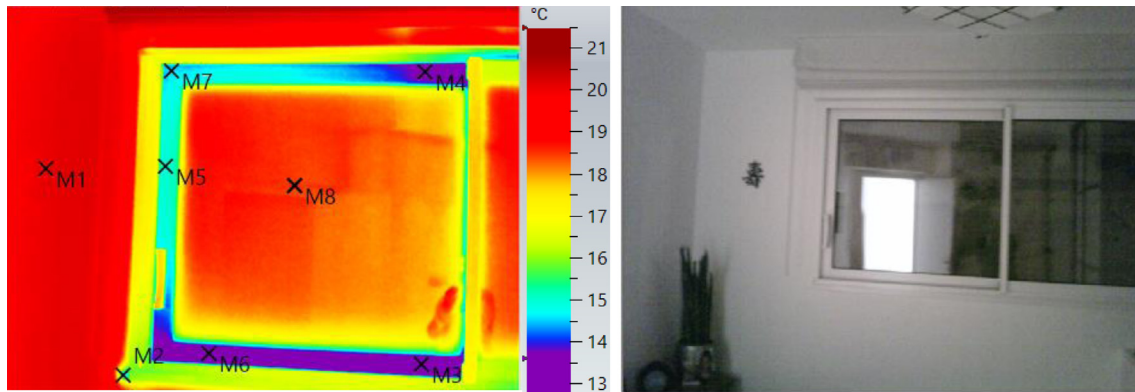
**Fig. 22.** Window thermogram on the left and real image on the right.

The following results are for the window in the master bedroom, red line in Figure 6. The window is facing the north. The window thermogram is illustrated in Figure 22.

Measured temperatures at various positions of the window are given in Table 10. M1 is the reference temperature. The M2 temperature is at 14.8 °C indication a small air leakage due a poor installation. M3 to M7 are temperatures around the window frame showing low temperatures comparing to the reference temperature. The colder the window frame the greater the conductive current and this great temperature difference is always causing air movement cycle that is felt a lot like a window draft by occupants. The constant cold surface temperatures make the bedroom especially unpleasant and uncomfortable and on end having major effects on quality of life. Moreover, the IR image of Figure 23 is illustrating an air leakage by the purple color at the bottom part of the window sash.

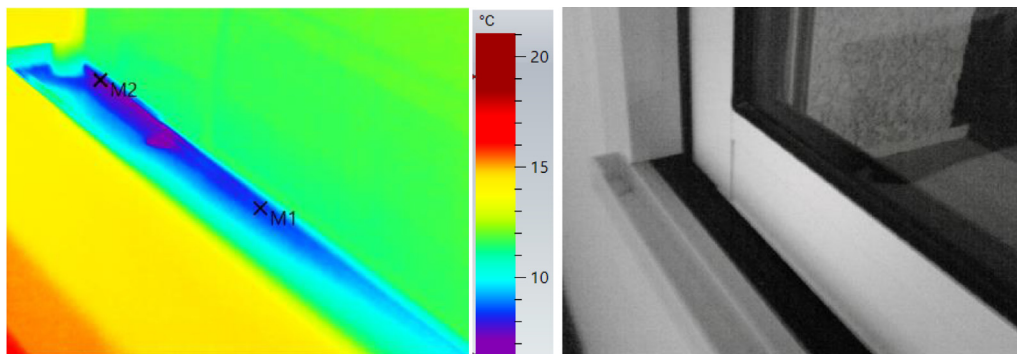
**Fig. 23.** Left: Air leakage at the lower part of the window. Real image on the right.

Table 11 shows temperatures at the cold-air leaks surrounding the sash.

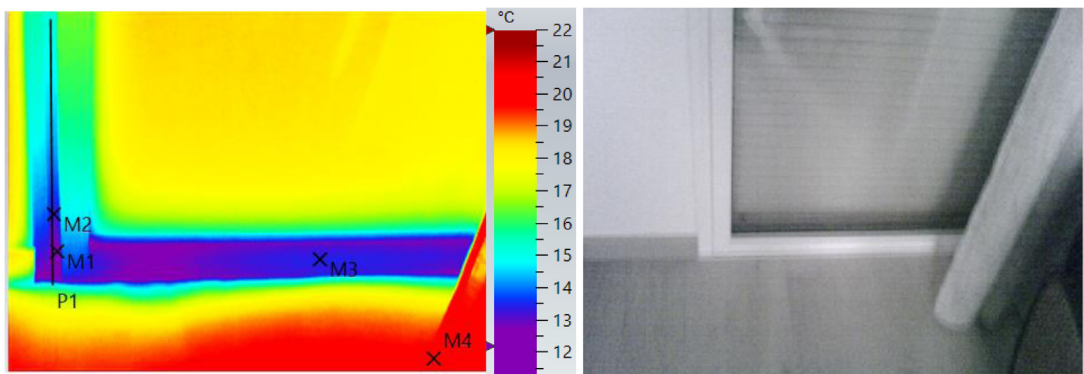
**Fig. 24.** Left: Thermogram of door window and the real image on the right.

Figure 24, is the thermogram of a window door of the room indicated by the orange line in Figure 6. The thermogram, is not only showing low temperatures at the bottom part of window frame but also air leakage along line P1 and the temperature profile is indicated in Figure 25. Table 12, are temperatures at the window door frame.

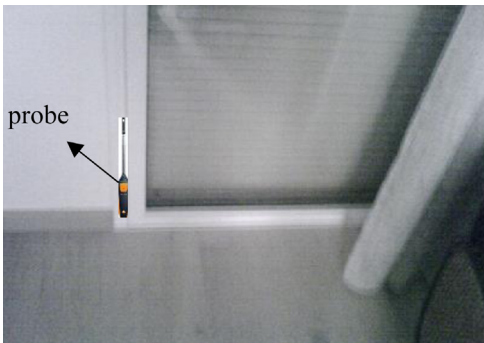
**Fig. 26.** Probe position to measure air leaking.

In face of the unexpected temperature profile in Figure 26, it seems interesting to perform another test at the windows to highlight the air leaking. A wireless smart probe such as Testo 405i thermal anemometer has been used to measure the air speed around all the windows.

The probe position was initially determined in the thermal image such the one along line P1 in Figure 25 and as illustrated in Figure 26. The air speed was measured between 10 min and 2 h.

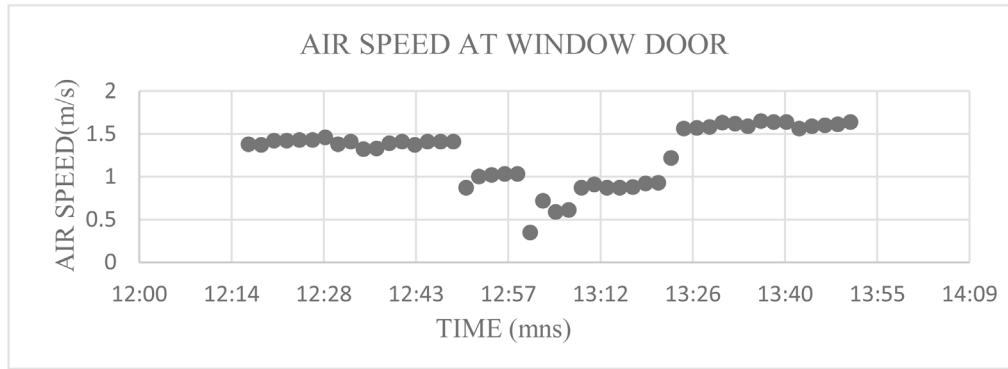
**Fig. 27.** Measuring air speed at the window door facing the south.

Only two relevant results are presented. The first one is along the window door at the orange line in Figure 6. The air speed was measured for more than 2 h as illustrated in Figure 27 and it can be observed that the air speed difference is between 0.5 m/s to 1.6 m/s.

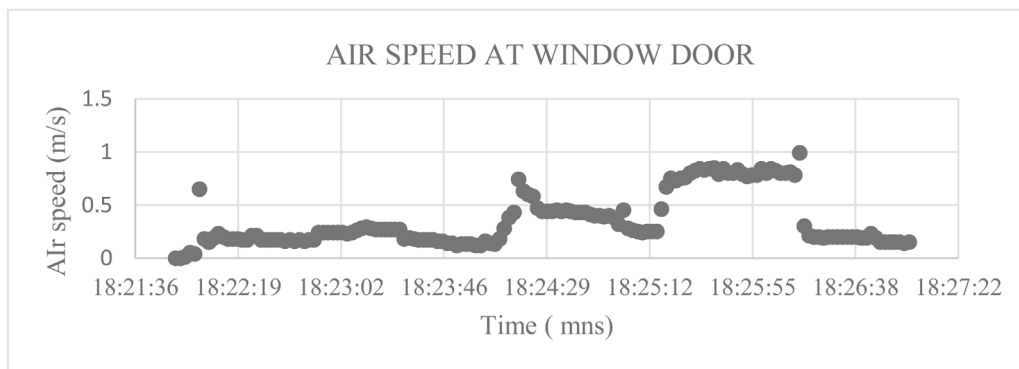
**Fig. 28.** Measuring air speed at the window door facing the north west.

The other test was performed on the window door which is at the yellow line in Figure 6, in a north west direction. The air speed was measured for nearly 10 min and is represented in Figure 28. We can see that the

maximum air speed is closed 1 m/s. Hence, these results attest that there exist an air leakage at some window doors.
